DDAS Accident Report

Report date: 18/01/2008	Accident number: 482
Accident time: 6:16	Accident Date: 21/08/2006
Where it occurred: Schull Mountain, Schull Village, Rasht District	Country: Tajikistan
Primary cause: Inadequate training (?)	Secondary cause: Field control inadequacy (?)
Class: Excavation accident	Date of main report: 31/08/2006
ID original source: None	Name of source: TMAC
Organisation: [Name removed]	
Mine/device: PMN AP blast	Ground condition: grass/grazing area rocks/stones
Date record created:	Date last modified: 18/01/2008
No of victims: 1	No of documents: 2

REPORT OF BOARD OF INQUIRY

INTO DEMINING ACCIDENT AT SHULL MOUNTAIN ON 21 AUGUST 2006

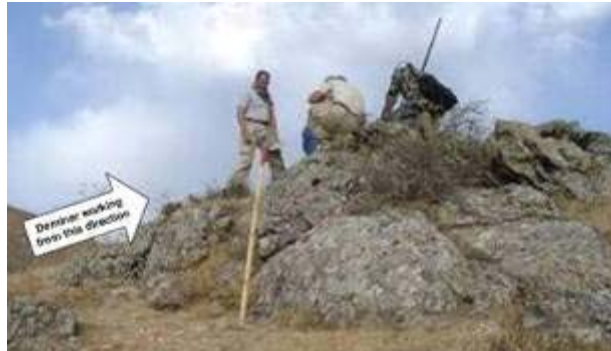
[The picture below shows the rocky outcrop where the accident occurred.]

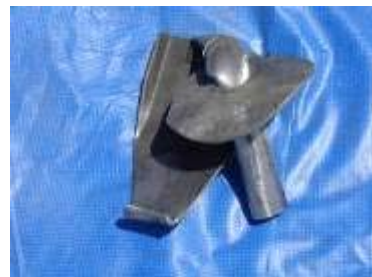
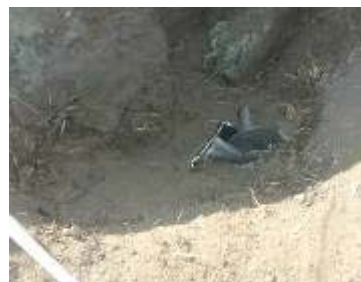
52. Prodger - A stainless steel prodger was found next to the crater and it was clear that, although ready for deployment, this tool was not in immediate use at the time when the mine detonated.
53. Pin hammer, normally used for driving wooden marker pickets into the ground. This was laid neatly on the ground, next to the manual prodger tool.
54. Trowel – A stainless steel, blast-resistant trowel, manufactured by LVP Technology of South Africa, (<http://www.lvptech.com/Main.htm>) was in the crater left by the blast of the mine. The trowel was severely damaged, the final 2cm of the point of the blade is rolled back on itself and the handle is bent completely over the blade.

[The trowel before and after the accident is shown below. This is sold as blast resistant because the material does not break. However, the length is not as recommended in IMAS, the metal handguard has broken and the handgrip has been removed in the blast.]

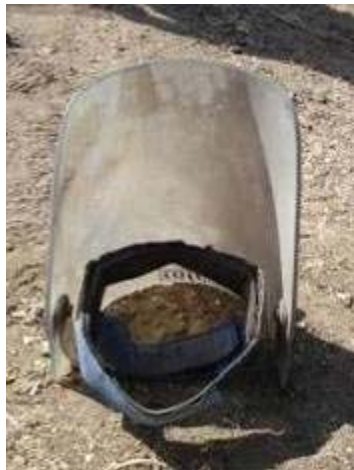
65. The blast resistant visor is the crux of this investigation. During the Board of Inquiry's time at the demining task site and the scene of the accident, a number of visors were observed by each member of the team. Some were in good condition, others were less so. If a visor is clear and clean and unmarked it is obviously easier to see through and there will obviously be less temptation for a deminer to lift his visor to attain a better view of his work or surroundings.

66. Protective facial visors are notoriously difficult to wear and deminers universally do not like to wear them. This is particularly the case in hot weather, when they can become fogged with condensation from the wearer's breath. When reasons for raising visors are given by deminers, they commonly make reference to a lack of optical clarity when looking through the visor. This may be blamed on light scratching, breath condensation, distracting optics (caused by reflections and refracted sunlight), airlessness and excessive heat. [The Victim's visor is shown below.]

67. There is sufficient damage inside the visor to suggest that it deflected environmental and mine-case fragmentation onto [the Victim's] face from the detonation of the PMN anti-personnel mine he was likely excavating at the time of the accident. From this it seems very likely that [the Victim] was using his trowel and excavating vertically over the mine with his visor at least partly raised.

- u) All personnel at all work sites should conform to all aspects of [International demining group]'s Standing Operational Procedures. Specifically, this should mean that, when they are working within hazardous areas, personnel deployed on mine clearance operations should wear PPE complete with visor in the fully down position to completely cover the wearer's face.

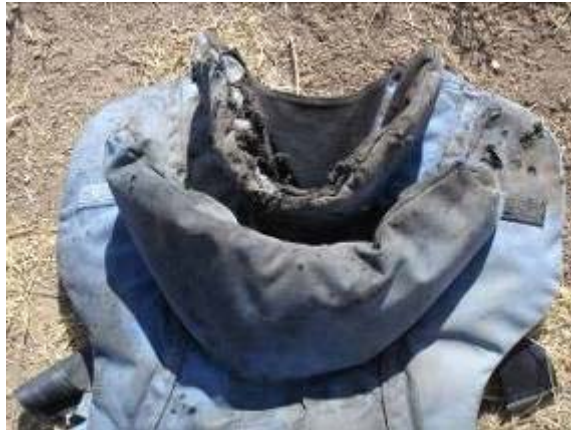
[Damage to the Victim's body armour makes it likely that a closed visor would have also sustained significant damage low down.]

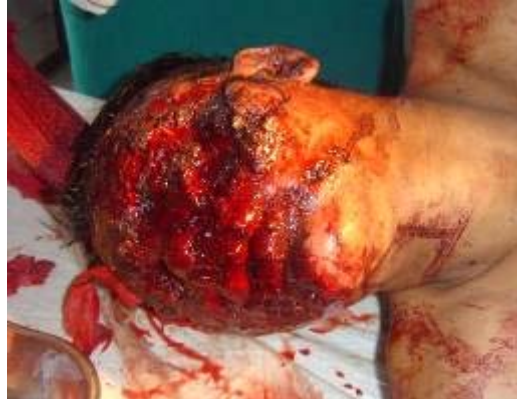
The pictures below show the Victim before and after surgery.

Photographs showed one leg bandaged top to bottom, the other peppered with small fragmentation wounds at the thigh. Both hands were bandaged and bloody with lacerations of the fingers.

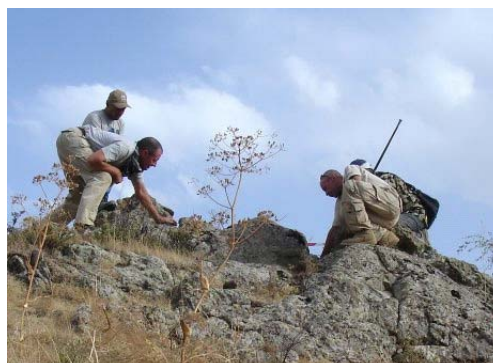
It is unfortunate that pictures of the accident investigation show International demining group expatriate investigators at the site wearing no PPE. This obviously sets a very bad example. They were inside a partly cleared minefield and – according to National standards and the demining group’s SOPs – should have been wearing PPE. The Bol investigators all wore PPE at the accident scene.

The International demining group investigators below are on the rocky outcrop where the accident occurred. The fact that they gave the picture to the Bol implies that they did not know that they were in breach of their own SOPs.
